FIELD SERVICE ACTION		
To: For the attention of: Please copy to:	All Dealers The Service Manager The Dealer Principal The Parts Manager Aston Martin Technician(s)	Reference: FSA:103
Model:	DB9	Issued: May 2004
VIN Range:	See attached list	
Subject:	Anti Roll Bar Drop Link Fixings	Page: 1 of 5

FIELD SERVICE ACTION		
To: All Dealers For the attention of: The Service Manager Please copy to: The Dealer Principal The Parts Manager Aston Martin Technician(s)	Reference: FSA: 106	Issued: July 2004 Page: 1 of 2
Model: DB9		
VIN Range: A00053, A00062, A00112, A00130 (4 cars only)		
Subject: Inlet Manifold Replacement

FIELD SERVICE ACTION		
To: For the attention of: Please copy to:	ALL UK & EUROPEAN DEALERS The Service Manager The Dealer Principal The Parts Manager Aston Martin Technician(s)	Reference: FSA 108
Model:	DB9	Issued: August 2004
Vin Range:	A00041 to A00368	
Subject:	Coolant Hose Fixing Replacement/ Adjustment	Page: 1 of 5

FIELD SERVICE ACTION		
To: For the attention of: Please copy to:	ALL UK and EUROPEAN DEALERS The Service Manager The Dealer Principal The Parts Manager Aston Martin Technician(s)	Reference: FSA 110
Model:	DB9	Issued: August 2004
Vin Range:	See attached list	
S

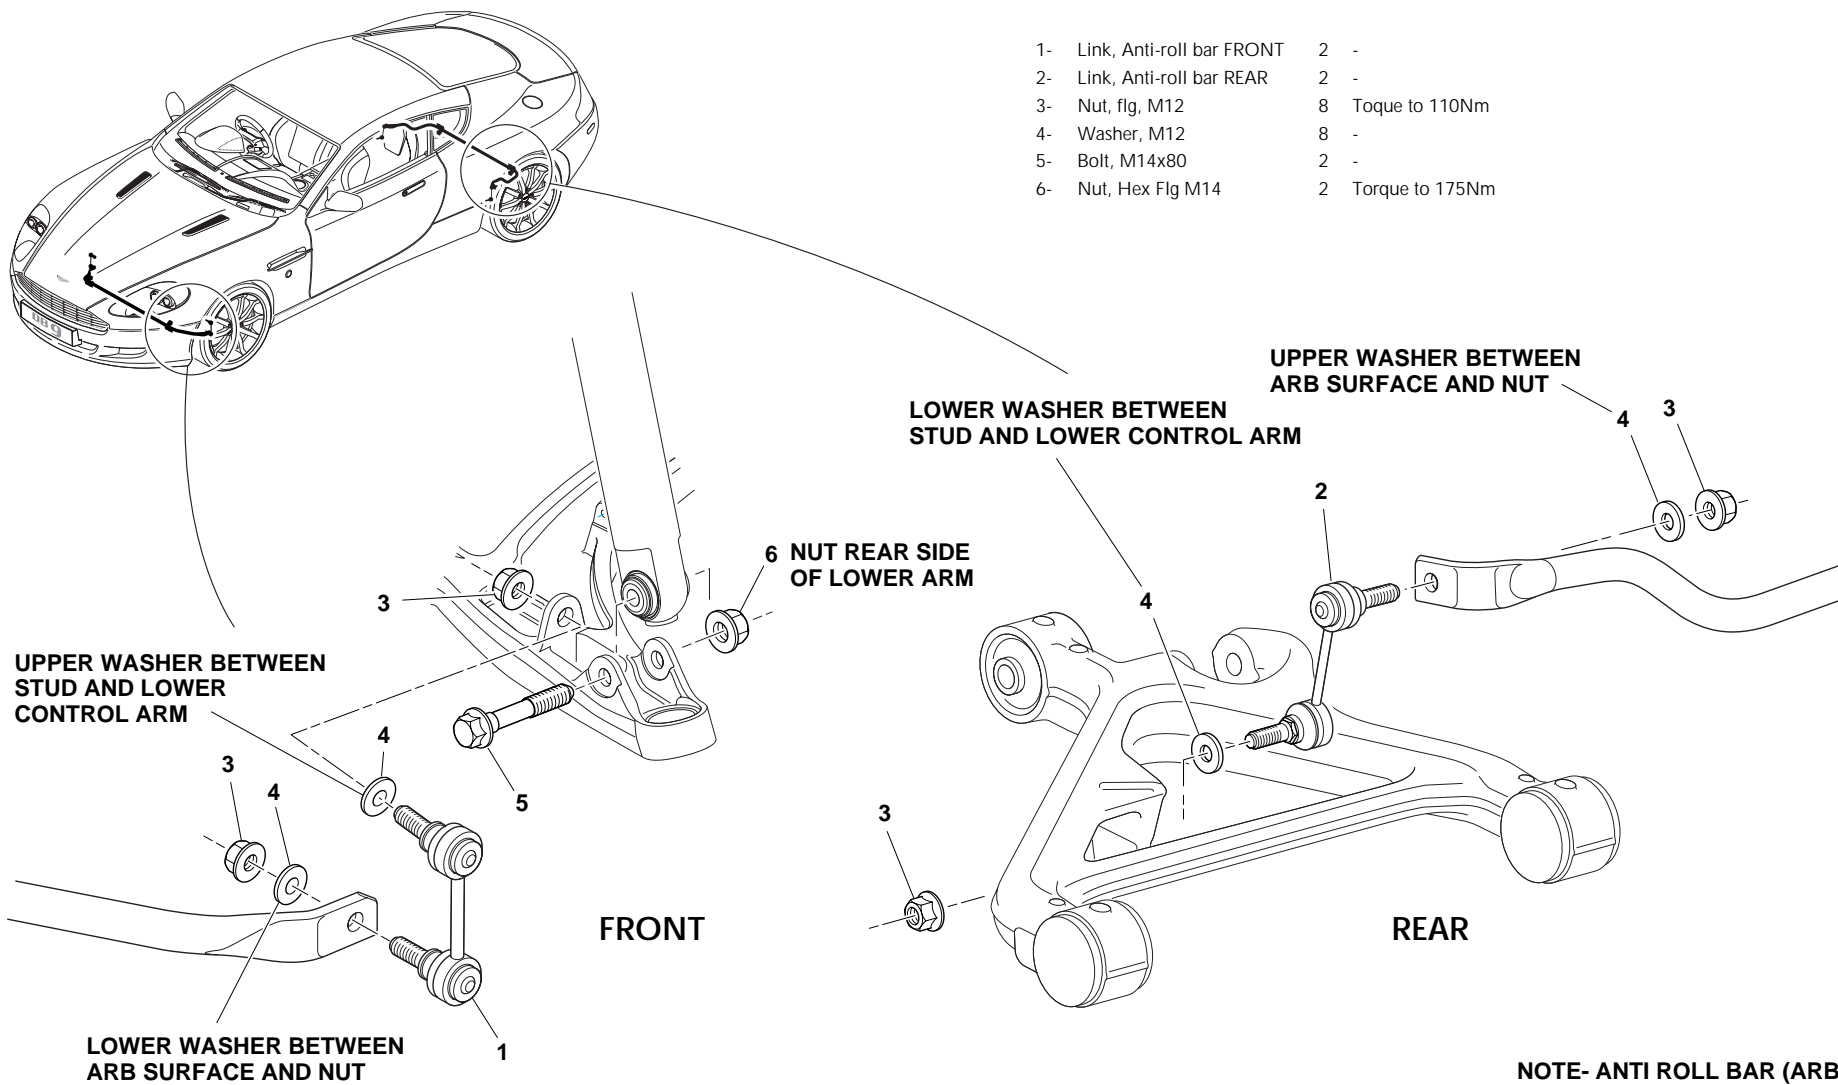
As a result of continuing Quality and Engineering investigations during the initial launch of DB9, a potential component quality issue has been identified on the Anti Roll Bar Drop Link fixings, front and rear. To address this issue, please carry out the following workshop procedure accurately as the order of assembly of the fixings is critical. See illustration for details.

- Swing the Damper outboard
- The Anti Roll Bar Link can now be removed
- Fit the new front Anti Roll Bar Link and fixings, from the Parts Kit supplied. **Note: Ensure that the order of assembly is correct in accordance with the attached illustration. At the lower fixing point the M12 Washer must be positioned between the Anti Roll Bar and the M12 Flange Nut. At the upper fixing point the M12 Washer must be positioned between the Anti Roll Bar Link and the Lower Control Arm.** Torque both M12 Flange Nuts to 110 Nm

- Swing the Damper back into position and from the supplied Parts Kit fit the new M14 Lower Damper Bolt and Flange Nut ensuring that the nut is rearward. See illustration attached (Items 5 and 6). Downward pressure on the control arm will be required to carry out this action

| 6- | Nut, Hex Flg M14 | 2 | Torque to 175Nm |

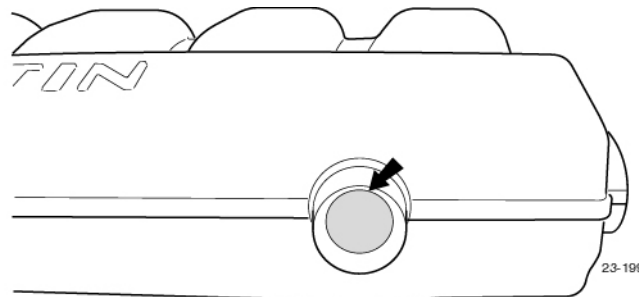
It has been identified during internal Quality investigations, that a small number of vehicles (4 cars only), may have been fitted with faulty inlet manifold assemblies. The issue is caused by a drilling error at the vacuum port for the brake booster. As shown in the illustration, the port may be off centre causing the manifold wall thickness to be below the specified 1.5mm, minimum tolerance.

Brake boost drilling not central and close to casting edge

To repair this issue the inlet manifold assemblies will need to be replaced. The inlet manifold inspection and possible replacement will however be carried out by a visiting Cosworth Engineer to your Dealership as soon as the vehicle is available. For vehicles that are already with the customer, this action will be carried out during the first routine Service interval.

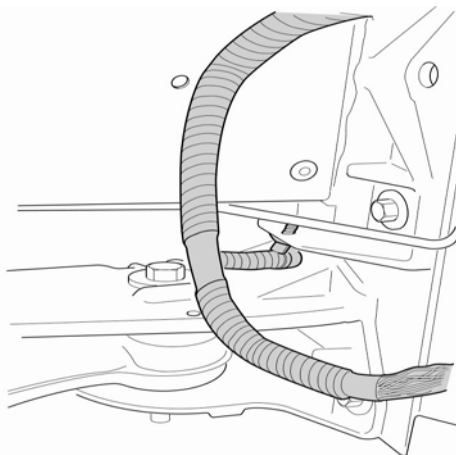
PRE RE-WORK CONDITION

As a consequence of recent ePDR's received from the Dealer network, it has become apparent that a number of vehicles within the above VIN range, require an inspection and re-route to eliminate a potential harness chafing condition. The concern raised is a consequence of the movement and lack of security between the A.B.S harness in relation to the L/H/F subframe.

- Ensure that DB9 workshop vehicle protection kit is fitted
- Position the DB9 on a wheels free ramp and raise the vehicle
- Remove the left hand front road wheel and wheel arch liner for access
- Inspect the A.B.S harness ensuring that no visual abrasions/damage are present

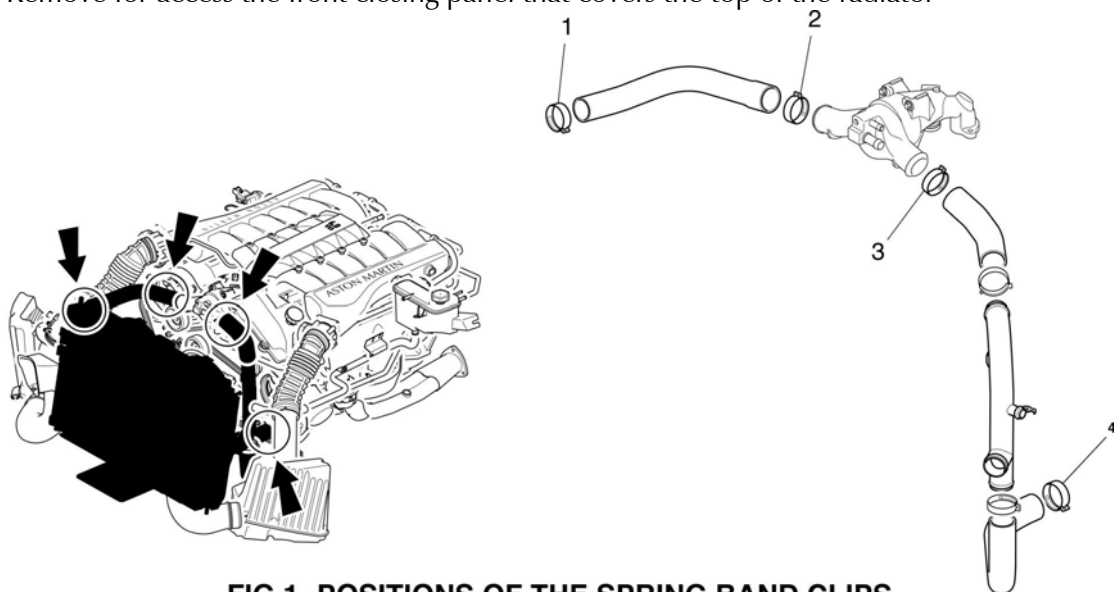
FIG 1- POSITIONS OF THE SPRING BAND CLIPS

In response to feedback received from our Engineering Department, two issues have been identified with Spring Band Clamps fitted to certain cooling system hoses on DB9. Harness damage may occur due to a potential foul condition between the front harness and the top radiator hose Spring Band Clamp. Additionally, some hose connections in the cooling system may potentially become unsecured as a result of contamination at the hose to spigot interface joints. This Field Service Action is therefore being released to advise the Dealer network to replace four Spring Band Clamps with Worm Drive Clips, also to orientate the top radiator breather hose Spring Band Clamp to prevent possible harness damage occurring in service.

- Inspect the Clips at positions 1, 2 and 3. If these are already Worm Band Clamps then ignore the next ten steps, but continue with the replacement of the clamp in position 4

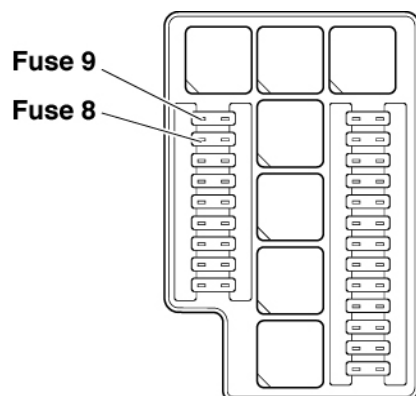
Boot Mounted Fuse Box (Located on the left hand side of the boot)

In response to feedback from our Engineering Department, it has been identified that possible fuel pump fuse failure may occur under certain conditions during the early life of the vehicle, whilst the fuel pumps are initially bedding in.

- Lift the boot lid
- Remove the carpet trim covering the boot fuse box (left hand side)
- Lift the lid off the boot mounted fuse box
- Remove x2 20-amp fuse's 8 and 9
- Replace fuse's 8 and 9 with 25-amp rated fuse's
- Refit boot fuse box lid
- Refit carpet trim
- Close the boot lid

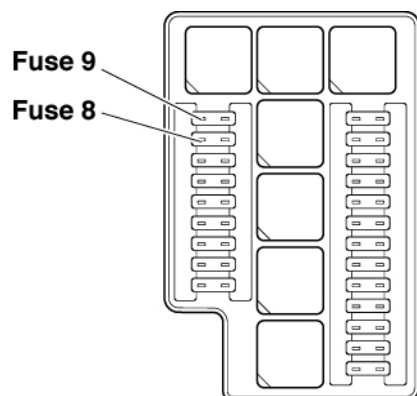
Boot Mounted Fuse Box (Located on the left hand side of the boot)

In response to feedback from our Engineering Department, it has been identified that possible fuel pump fuse failure may occur under certain conditions during the early life of the vehicle, whilst the fuel pumps are initially bedding in.

- Lift the boot lid
- Remove the carpet trim covering the boot fuse box (left hand side)
- Lift the lid off the boot mounted fuse box
- Remove x2 20-amp fuse's 8 and 9
- Replace fuse's 8 and 9 with 25-amp rated fuse's
- Refit boot fuse box lid
- Refit carpet trim
- Close the boot lid

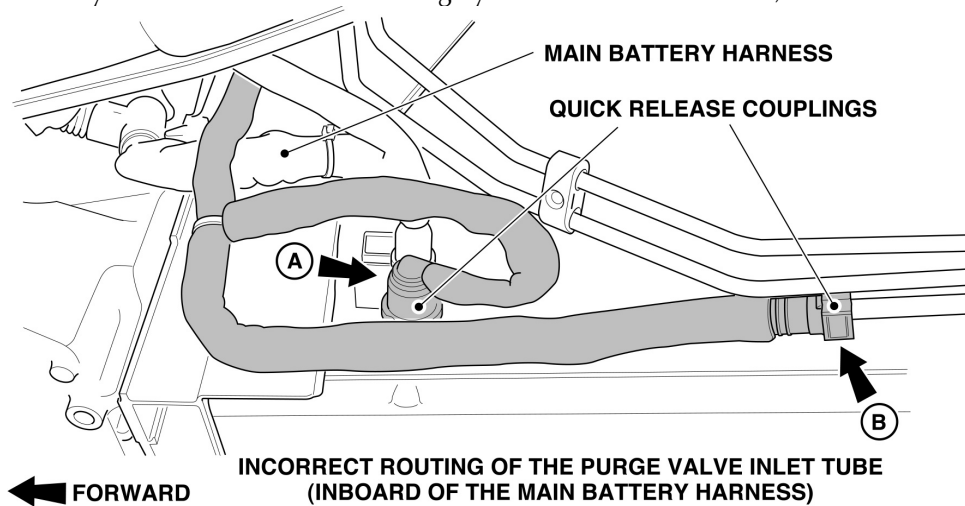
FIGURE 1

As a result of continuing Quality and Engineering investigations during the initial launch of DB9, it has been identified that there is the potential for the Purge Valve Inlet Tube, to potentially come in contact with the exhaust manifold, which could result in the heat shielding becoming damaged.

- Place the vehicle on a vehicle lift, raise and remove the front under tray. (Early cars will also need the Alternator cooling duct and pipe to be removed)
- Locate the Purge Valve Inlet Tube situated on the right-hand side of the vehicle
- Inspect the Purge Valve Inlet Tube for incorrect routing (see Figure 1 for the incorrect routing) and the latest level heat insulation material (latest material is a bright silver foil like material early cars were fitted with a satin grey silicone flexible material)
