SERVICE ACTION RECALL		
To: For the attention of: Please copy to:	All Dealers / MEAM The Dealer Principal The Service Manager The Sales Manager The Parts Manager Warranty Administrator Aston Martin Technician(s)	Reference: SAR 011 Issued: November 2005
Model:	DB9	
Vin Range:	A04048 – B04296 – See attached VIN list	
Subject:	ZF Automatic Transmission –Parking Pawl Glide Plate	Page: 1 of 7

SERVICE ACTION RECALL		
To:	All Dealers / MEAM	Reference: SAR 011 Issued: November 2005
For the attention of:	The Dealer Principal	
Please copy to:	The Service Manager The Sales Manager The Parts Manager Warranty Administrator Aston Martin Technician(s)	
Model:	DB9	
Vin Range:	A04048 – B04296 – See attached VIN list	Page: 1 of 7
Subject:	ZF Automatic Transmission –Parking Pawl Glide Plate

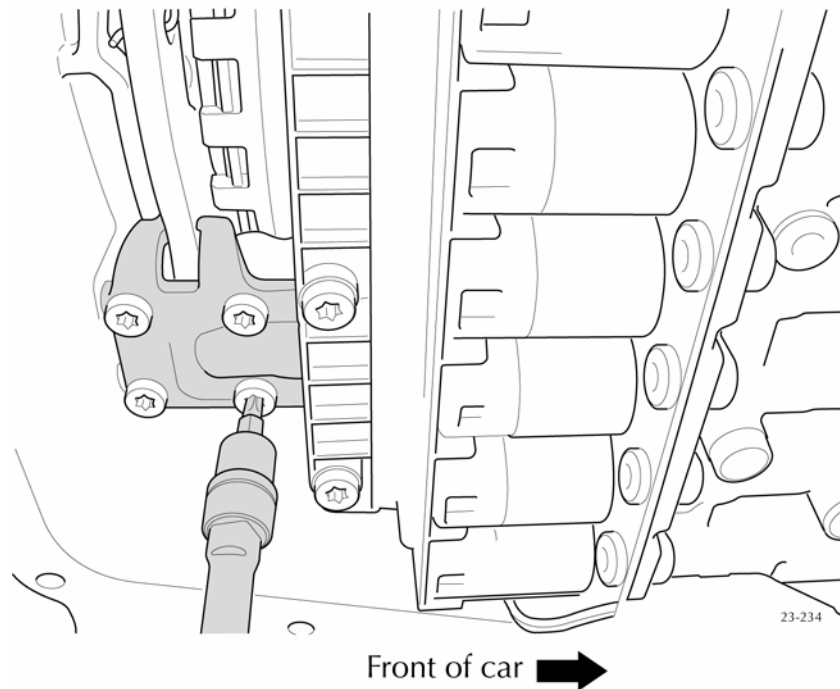
Figure 1

Following field investigations, it has been identified that a number of Aston Martin DB9 models have been assembled with an automatic transmission (parking pawl glide plate) that may not have been subjected to the required heat treatment process and therefore is not hardened correctly. Consequently, Park may not engage even if the park button in the vehicle is pressed to select Park and all driver indicators show the Park position has been achieved.

- Disconnect the oil cooler pipes from the gearbox at the thermostat and remove the pipework/thermostat assembly
- Drain the gearbox oil into a clean container for re-use, and refit the drain plug
- Remove the gearbox oil pan
- Locate and remove the Park Pawl Guide Plate by removing the four Torx screws and ease the old plate out of the gearbox, (see figure 1). Retain the displaced part for warranty return

- Fit the new Park Pawl Guide Plate and tighten the four Torx screws to 10Nm
- Check the park pawl is free to move
- Refit the gearbox oil pan, (confirm that the original gasket is clean and fully seated before refitting the gearbox oil pan) and cross torque all screws to 7-9Nm
