FIELD SERVICE ACTION		
To: For the attention of: Please copy to:	All Dealers The Service Manager The Dealer Principal The Parts Manager Aston Martin Technician(s)	Reference: FSA:103
Model:	DB9	Issued: May 2004
VIN Range:	See attached list	
Subject:	Anti Roll Bar Drop Link Fixings	Page: 1 of 5

FIELD SERVICE ACTION		
To: All Dealers For the attention of: The Service Manager Please copy to: The Dealer Principal The Parts Manager Aston Martin Technician(s)	Reference: FSA: 106	Issued: July 2004 Page: 1 of 2
Model: DB9		
VIN Range: A00053, A00062, A00112, A00130 (4 cars only)		
Subject: Inlet Manifold Replacement

FIELD SERVICE ACTION		
To: For the attention of: Please copy to:	ALL UK & EUROPEAN DEALERS The Service Manager The Dealer Principal The Parts Manager Aston Martin Technician(s)	Reference: FSA 108
Model:	DB9	Issued: August 2004
Vin Range:	A00041 to A00368	
Subject:	Coolant Hose Fixing Replacement/ Adjustment	Page: 1 of 5

FIELD SERVICE ACTION		
To: For the attention of: Please copy to:	ALL UK and EUROPEAN DEALERS The Service Manager The Dealer Principal The Parts Manager Aston Martin Technician(s)	Reference: FSA 110
Model:	DB9	Issued: August 2004
Vin Range:	See attached list	
S

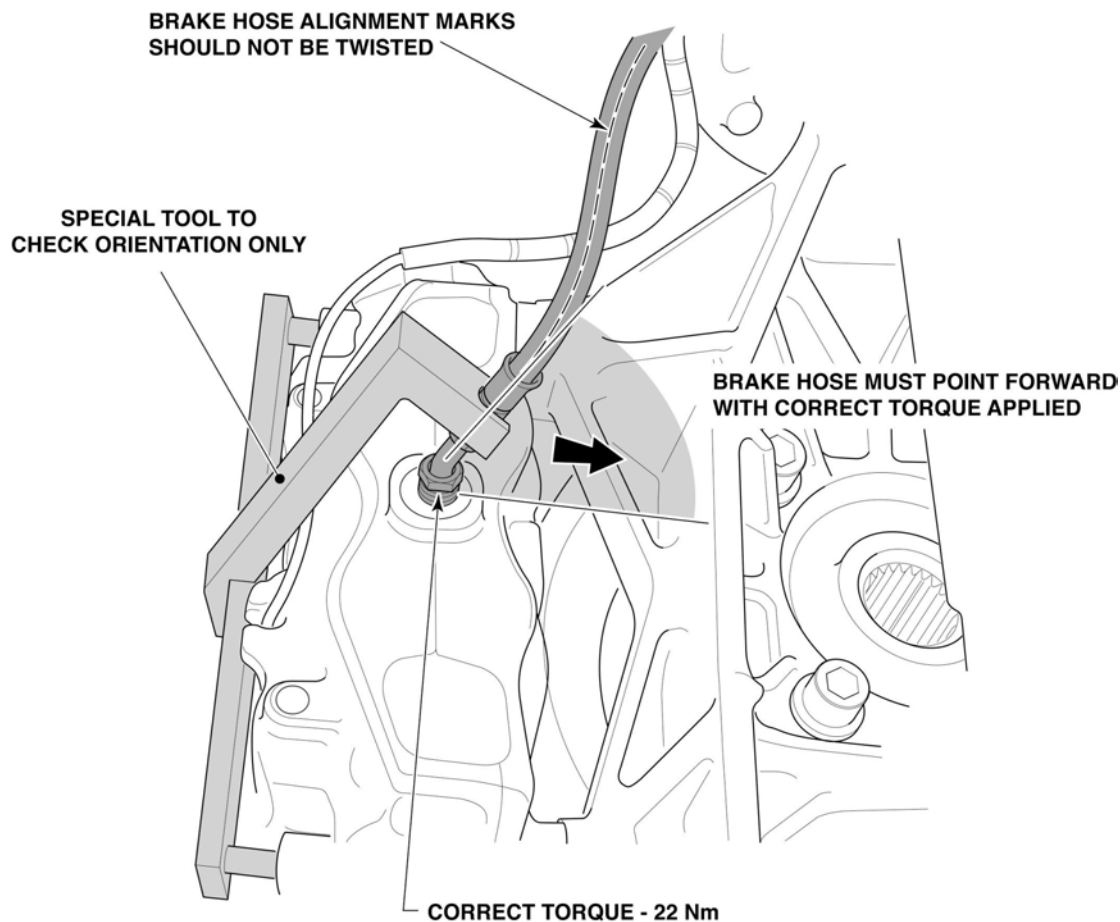
Figure 1

Note:- figure 1 shows Left hand front caliper only, the brake pipe will still route towards the front of the car on the right hand side

AS VIEWED LOOKING FROM UNDERNEATH THE LH WHEELARCH

- If the torque is correct, the pipe did not move during checking and the alignment is correct, no further action is required
- If the pipe is seen to move due to the torque being incorrect, or if the pipe orientation is incorrect, proceed as follows:
- Carefully back off the flexible hose union at the brake caliper until the pipe can be rotated backwards to allow forward movement when being re-torqued
- Re-torque the brake pipe union to 22Nm, then recheck all alignments as listed above
- If the correct alignment is not achieved readjust until the correct alignment is achieved
- Refit the front road wheels and initially torque to first 80 Nm then again to 135 Nm using a cross torque pattern

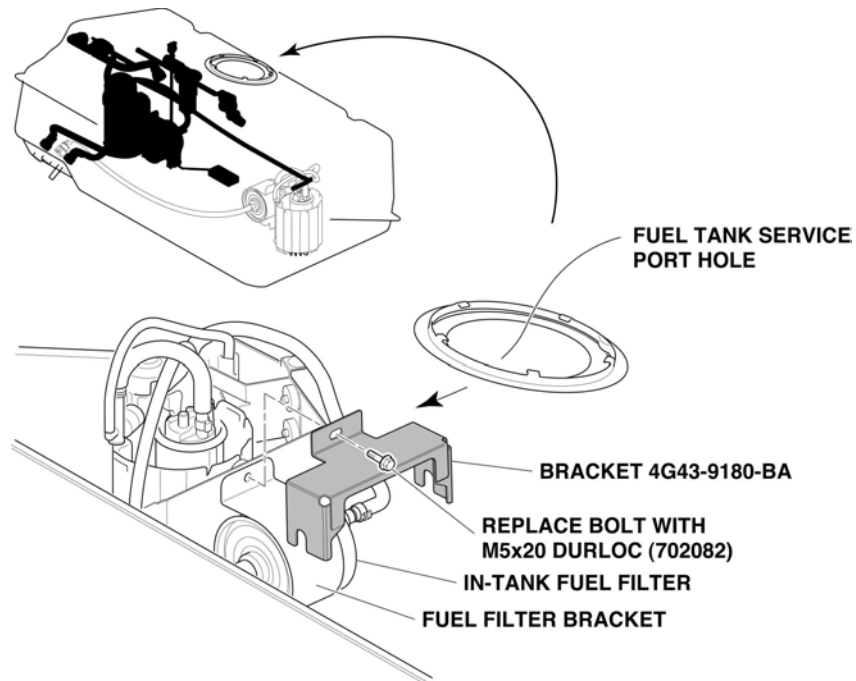
- Install the fuel drainage adaptor, using service tool 310-136
 - Recover the fuel according to the fuel recovery unit instructions
 - After draining the tank remove the adaptor
 - Inspect the fuel filter connections, ensuring both are firmly located against the base of the filter housing. (The clamp bracket will only fit if the connections are in the correct position)
- 1, Remove and discard the left hand side fuel filter-retaining bolt
 - 2, Place the clamping bracket over the filter, securing the connectors within the retaining slots

- 3, Re-secure the fuel filter using the new M5 Durlock (supplied) and torque to 10Nm
- Repeat items 1 to 3 on the right hand side fuel filter
 - Renew the service cover seal and refit the service cover, using JD 174 (Ensure the service cover is correctly aligned)

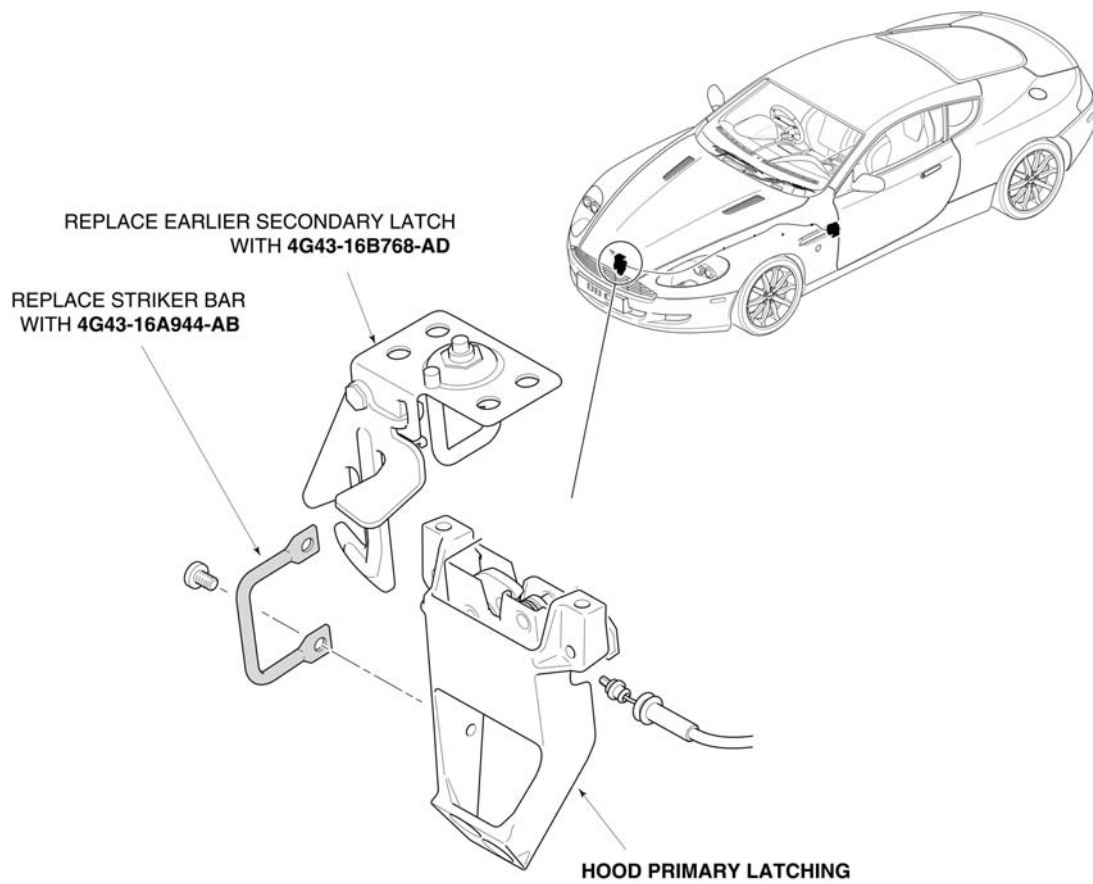
FIGURE 1

This Field Service Action is therefore being instigated to ensure that all DB9 vehicles within the above listed VIN ranges have their Bonnet Secondary Striker Bar and Latch assemblies inspected and replaced with new parts, (see Figure 1 overleaf).

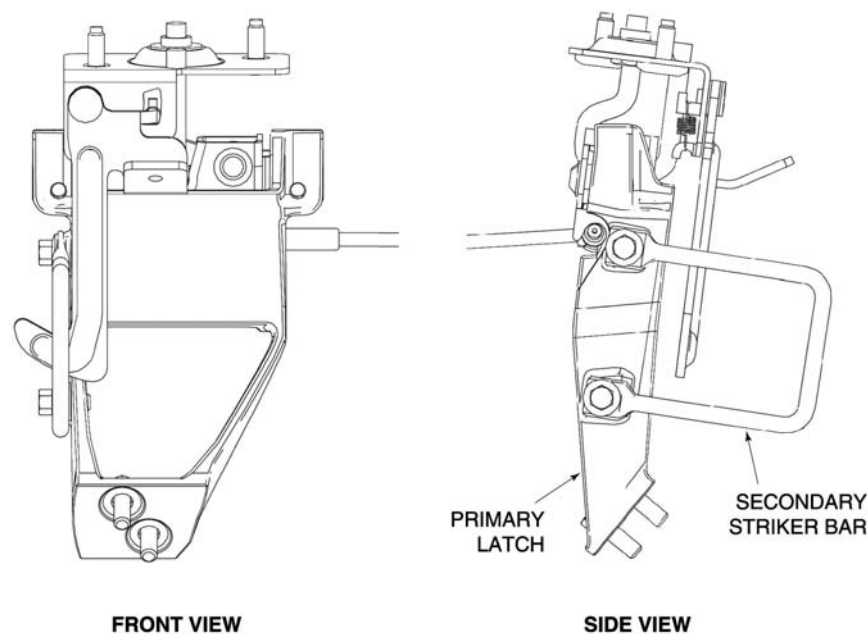
FIGURE 4

- 1/ The Secondary Latch hook must always be under the Secondary Striker Bar, so the hook catches the Striker Bar if the Primary latch is inadvertently operated
- 2/ The Secondary Latch must operate freely with the spring tension/pivot allowing the latch to operate without binding. If the Secondary Latch does not return to its neutral position after the finger tab is operated, the Secondary Latch assembly should be replaced
- 3/ The Secondary Latch hook must not be bent to obtain the correct alignment or be used as a pull shut aid to bonnet closure

- Adjust height of Primary Loop to obtain correct bonnet height.
- When the new Secondary Latch and Striker Bar have been fitted and all adjustments have been carried out with bolts tightened, carry out a final inspection by closing the bonnet, check the Secondary Latch does not foul the slam panel at any point and using a lead lamp, look through the front grille to check that the Secondary Latch is in the correct position and has not been misplaced, (see Figure 4 below)

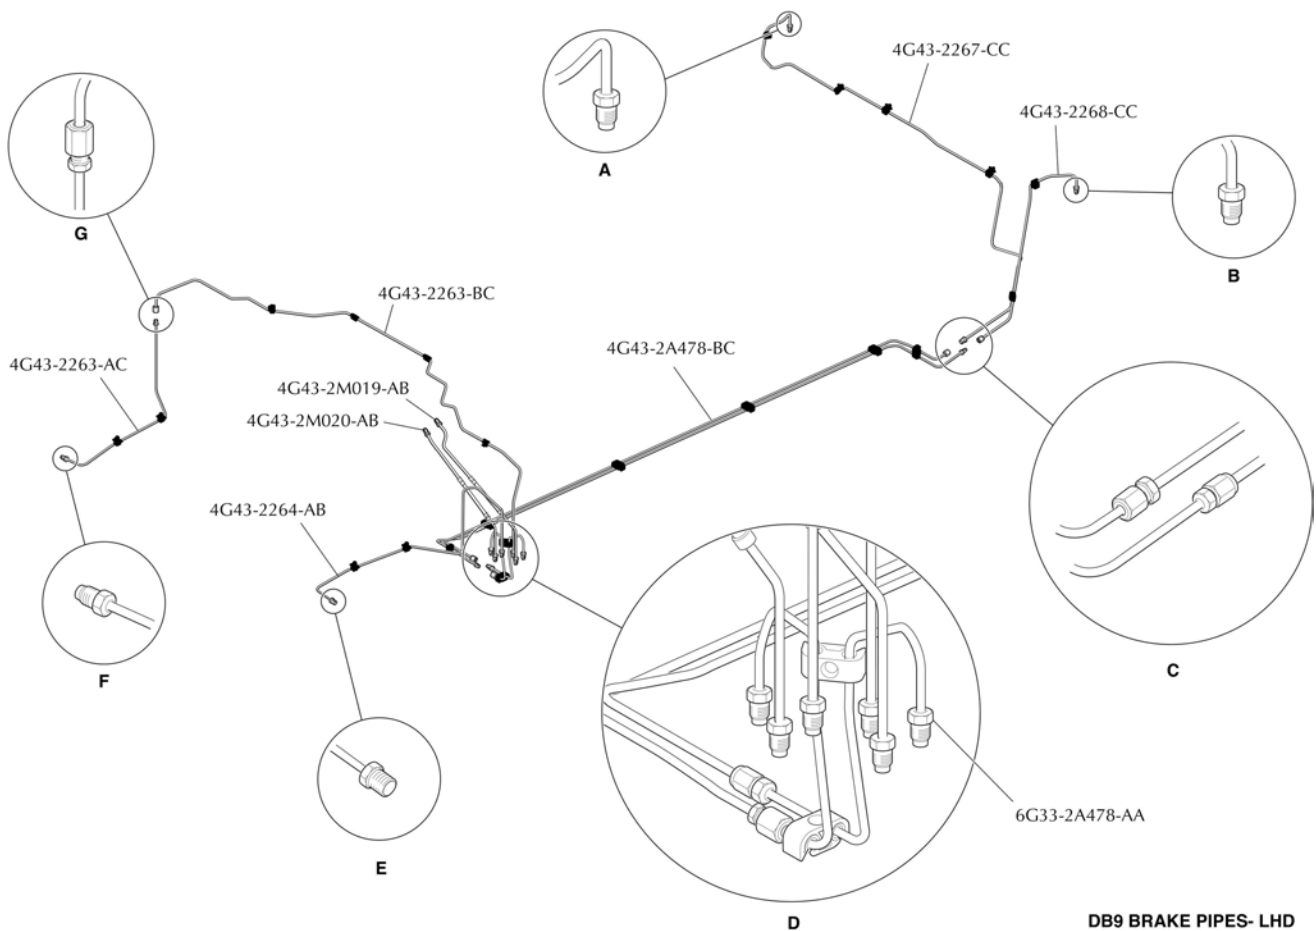
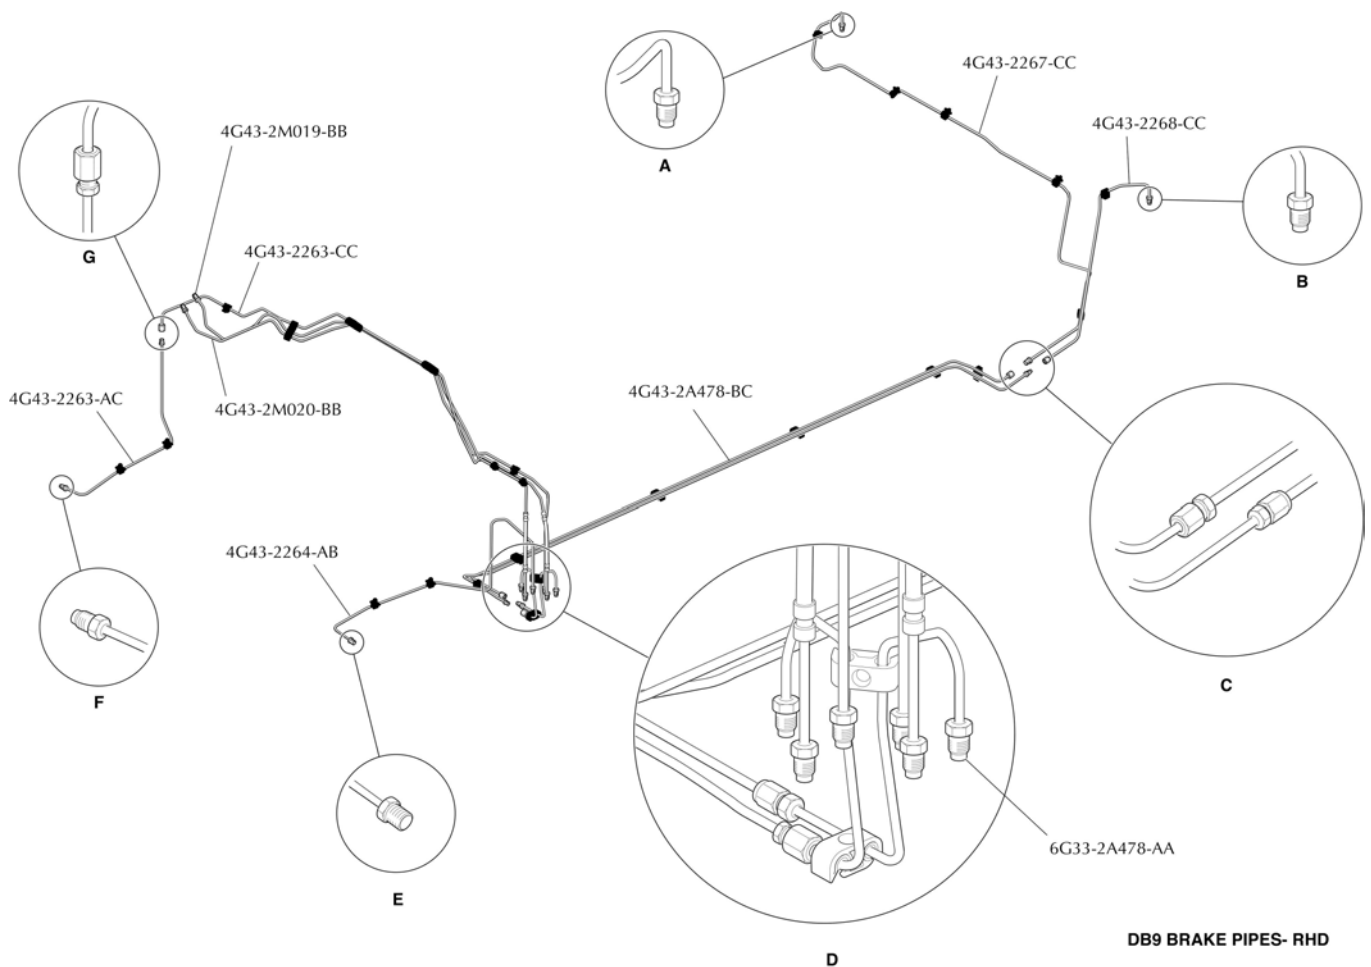
- In area C, on a vehicle with Right Hand Steering, the in-line brake pipe joint can be inspected from above through the engine bay. On a vehicle with Left Hand Steering, the right hand front wheel and wheel arch liner will require removal to inspect the in-line brake pipe joint
- If any fluid seepage is identified, contact Aston Martin Service Operation for further instructions and Warranty Authorisation

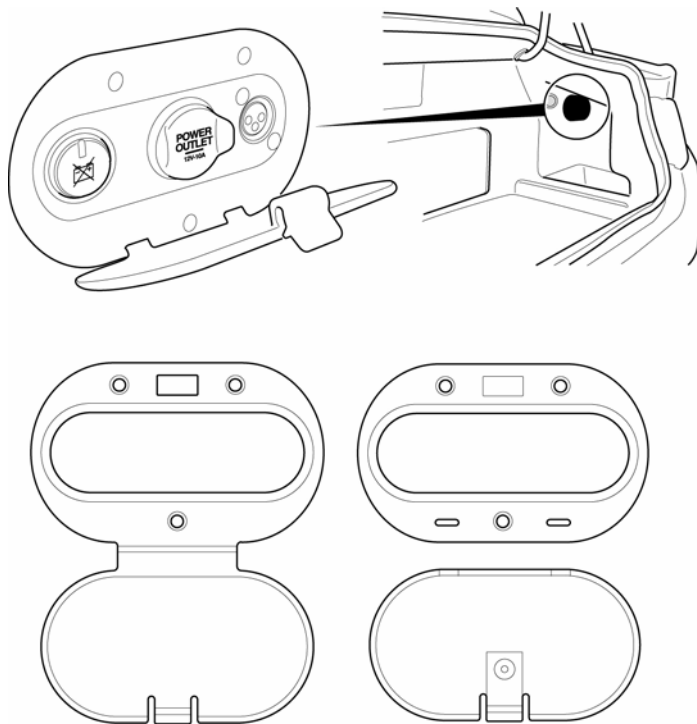
Figure 1

In response to Dealer feedback, we are releasing this Field Service Action to replace the Battery Disconnect/Auxiliary Power Socket Cover, to prevent inadvertent operation of the BDS (Battery Disconnect Switch) and loss of the coverlid.

- Open the boot/trunk and locate the BDS/ Auxiliary Socket Cover, (figure 1 overleaf)
- Open/remove the old specification cover lid, (note:- some vehicles did not have a cover lid fitted)
- Remove the three screws that retain the old level back plate of the cover assembly
- Discard both parts of the old level cover assembly
- Fit the new one piece BDS/ Auxiliary Socket Cover using the original three screws
- Check that the cover closes correctly
- Close the boot/trunk and remove the protection kit

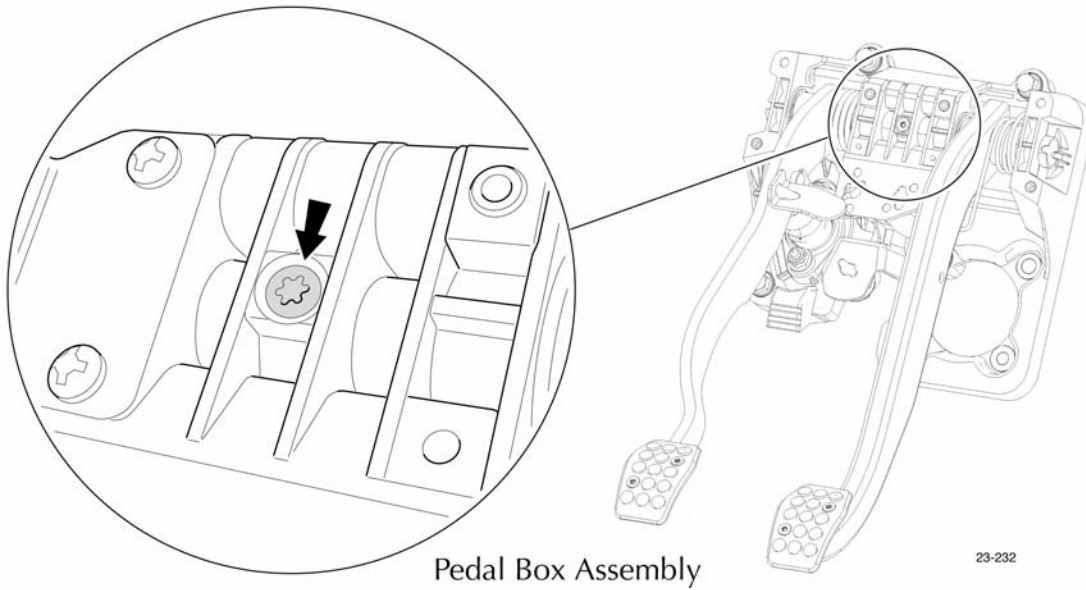
Figure 1

It has been identified during internal quality inspections that a number of Aston Martin DB9 vehicles may have a potential issue with the Pedal Box Assembly. The secondary locking screw may become loose and if it becomes detached this could potentially allow lateral movement of the pedal pivot tube if either of the primary location tangs were to become displaced

- Ensure that all the relevant DB9 workshop protection kit is fitted
- Locate the Central Pivot Tube locking screw on the Pedal Box assembly (See figure 1 overleaf)
- The screw will be one of two types, either a Torx 25 counter sunk screw or a Phillips POZIDRIV® dome head screw
- Check that the Pivot Tube locking screw is correctly located, if it is, do nothing (do not attempt to tighten it). If the screw is missing, then replace the pedal box assembly
- Also check both ends of the Pivot Tube to ensure that the cut out in the left hand side of the Pivot Tube, is fully engaged into the fixed tang. Now check that the cut out, in the right hand side of the Pivot Tube is fully engaged into the flexible tang. If the Pivot Tube is not seated fully at either end or the flexible tang is missing, replace the Pedal Box assembly (see figure 2 overleaf)

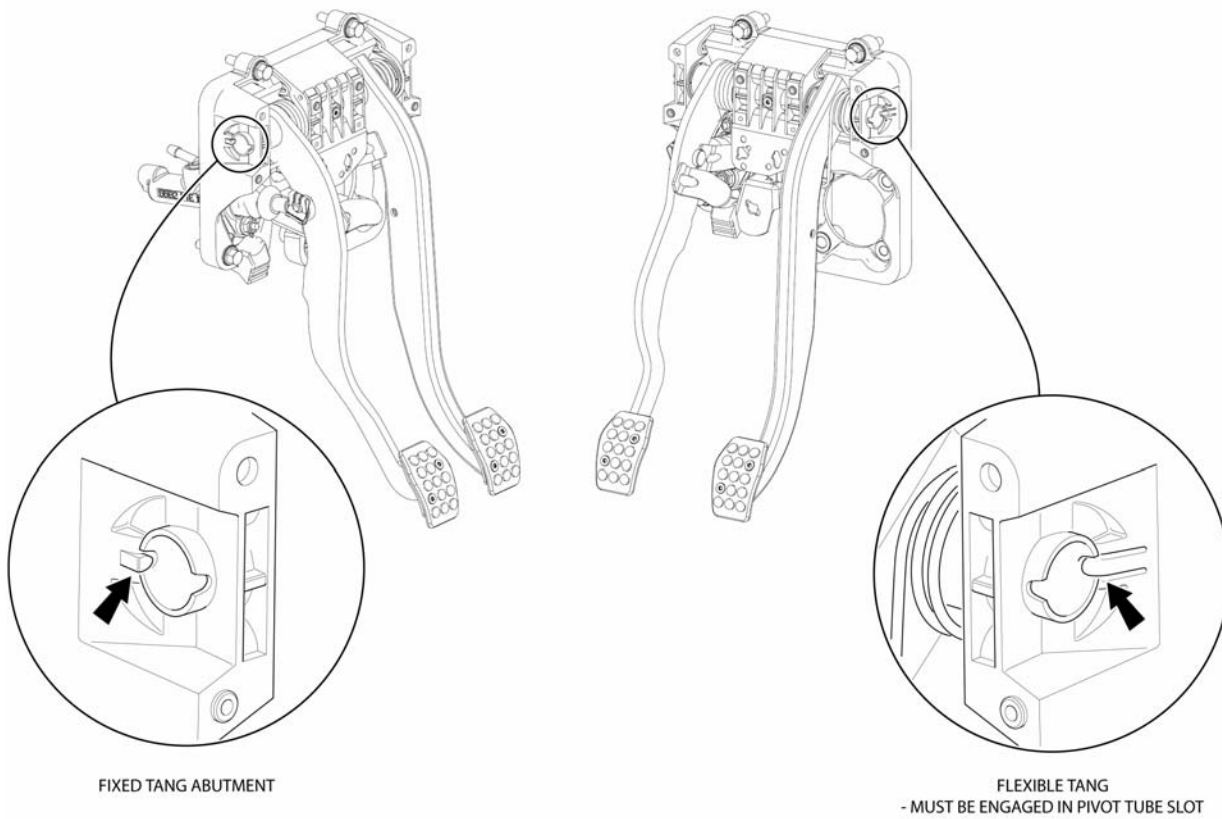
Figure 2

**PIVOT TUBE DETAIL SHOWING LOCATING/ RETAINING TANG'S
ON THE BRAKE CLUTCH ACTUATION UNIT (RHD SHOWN)**

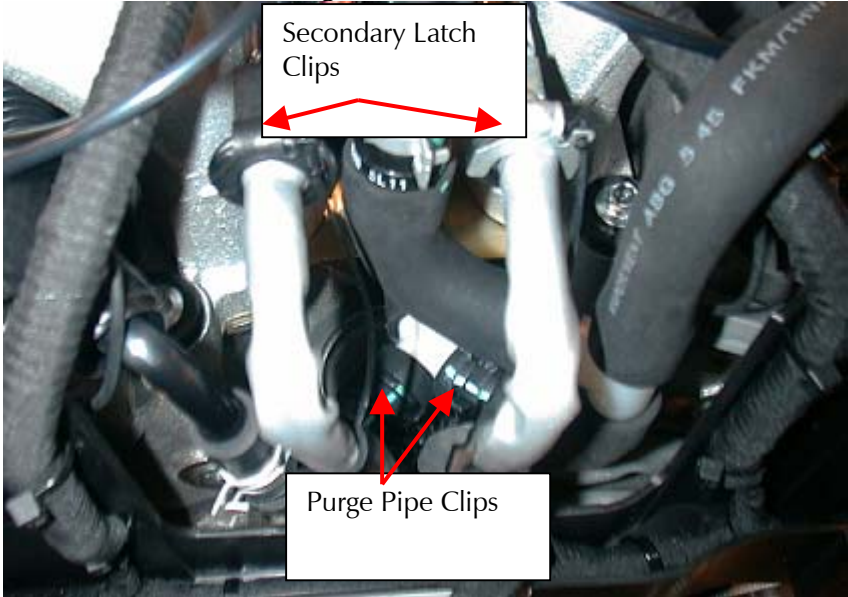
Figure 5

Ensure you do not catch the New fuel pipes on the Purge pipe clips. (See Figure 5)

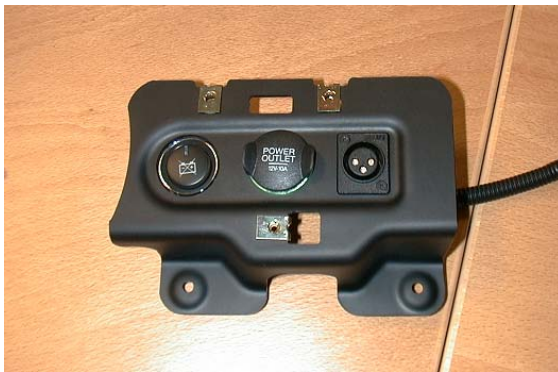
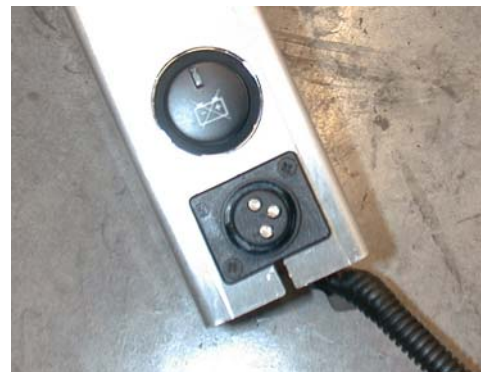
Figure 4

3. However, cars built between VIN *05158 and *05242 DB9 and C00844 and C00870 V8 Vantage may be built to either condition or possibly have the incorrect Batter Conditioner supplied only.

- If car has a 3-pin connector as shown in Figure 4. Connect Fluke your Multimeter and using adaptor 43-27751 check to see if you get a battery voltage reading.

- If you can get a battery voltage reading make sure vehicle has got a Battery Conditioner with a connector as shown in Figure 1.
- If you cannot get a battery voltage reading remove the 3-pin connector from the vehicle and fit blanking grommet Part Number: 702725
- DB9 Variants only see Figure 5. Make sure the car has been supplied with the correct Battery Conditioner with a connector as shown in Figure 2
- Due to Vehicles Owner's Guides being incorrect, print and insert the following picture in the vehicles Battery Conditioner box and inform customers of this change. See Figure 6
